LIDT Modification Following Debris Damage

S.G.S. Harrison, D.C. Carroll, M. Notley, R. Heathcote, and R.J. Clarke
Rutherford Appleton Laboratory, Didcot, UK

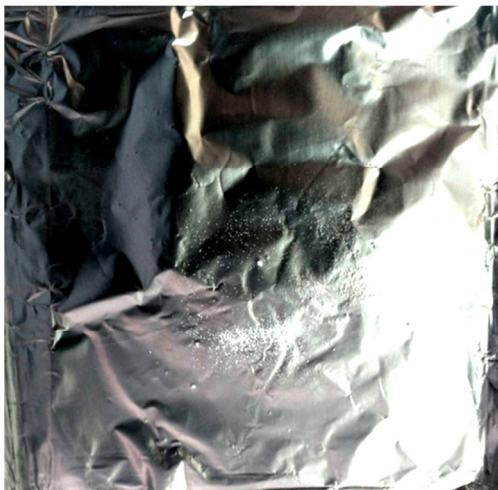
In solid target interactions debris is ejected from the target from many different mechanisms but can generally be categorised under “soft” coatings or “bullet-like” fragments. The latter of these can penetrate surface coatings and cause damage to the optical substrates due to high impact velocities. Much of this damage is observed as small pinholes in the optical coatings but with thicker targets damage has been observed on the millimetre scale. Target fragments can easily penetrate through tens of microns of material as can be seen in figure 1.

Figure 1. Debris holes penetrating 150 μ m aluminium foil placed inside the TAW interaction chamber, 300mm from target normal rear.

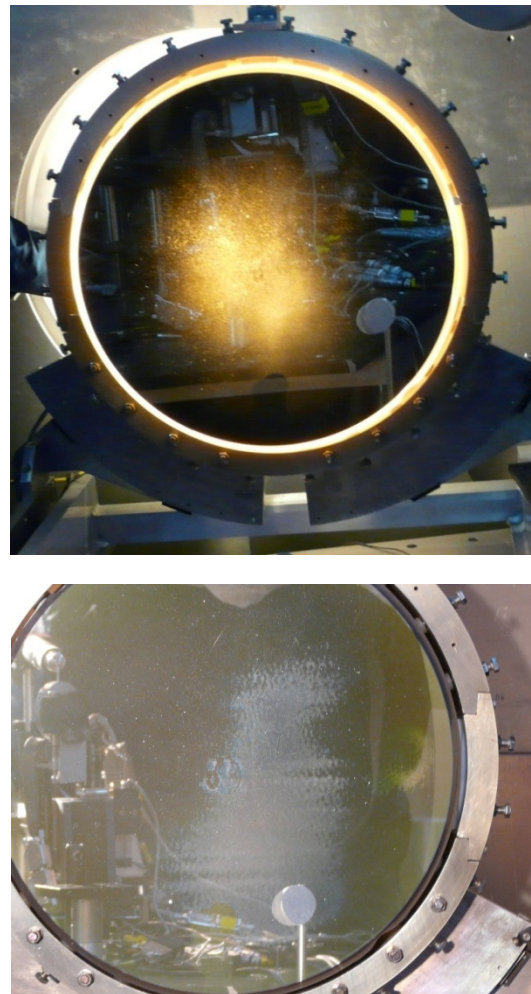
Over the first 10 years of TAP operations the parabola has been switched between the 2 available substrates 5 times. Each of the substrates was in operation for approximately 3 years before their respective first recoating. With no debris protection, small pinholes were observed throughout the parabola coating, observable via high brightness illumination behind the substrate (figure 3a). However, the overall parabola reflectivity and focal spots did not appear to be greatly affected and the switch between parabolas was only initiated once beam imprints were observed on the coating (figure 3b). Following each subsequent recoating the parabola lifetime dropped significantly.

The rapid deterioration of the silver parabola is believed to be due to debris primarily removing the protective layer over the silver coating. This exposes the silver layer to the external environment which causes oxidation of the silver. The LIDT of oxidised silver is calculated to be ~ 50x lower than the natural protected silver coating (around 0.08 Jcm^{-1}). With such a low LIDT the oxidised silver immediately damages causing material blow-off and further damage to the surrounding protective layers – exposing further localised exposure of the silver coating to the atmosphere. This process creates a growth of the damage site from a small pin-hole into an expanding damage site. Since the localised damage is through the lowered LIDT the appearance is of laser beam damage

whereas in fact it is generated through this loss of the silver protective layer.

During recoating, the entire coating is etched away leaving only the substrate. The substrate has surface damage from the target debris which has penetrated the 100's nm silver and protective overcoat. With a simple recoat, no surface polishing is undertaken and the new coating layers are directly applied to the damaged substrate. This creates coating imperfections where some areas – predominantly on the impact crater walls and floor – are left with minimal or no protective layer. Within these areas the lower LIDT from silver oxide exists and the overall damage process restarts.

Figure 3. Images of the TAP final focussing parabola. The top image shows the presence of the pinholes when illuminated from behind, and the bottom image shows the parabola unilluminated to display the beam damage to the coating .

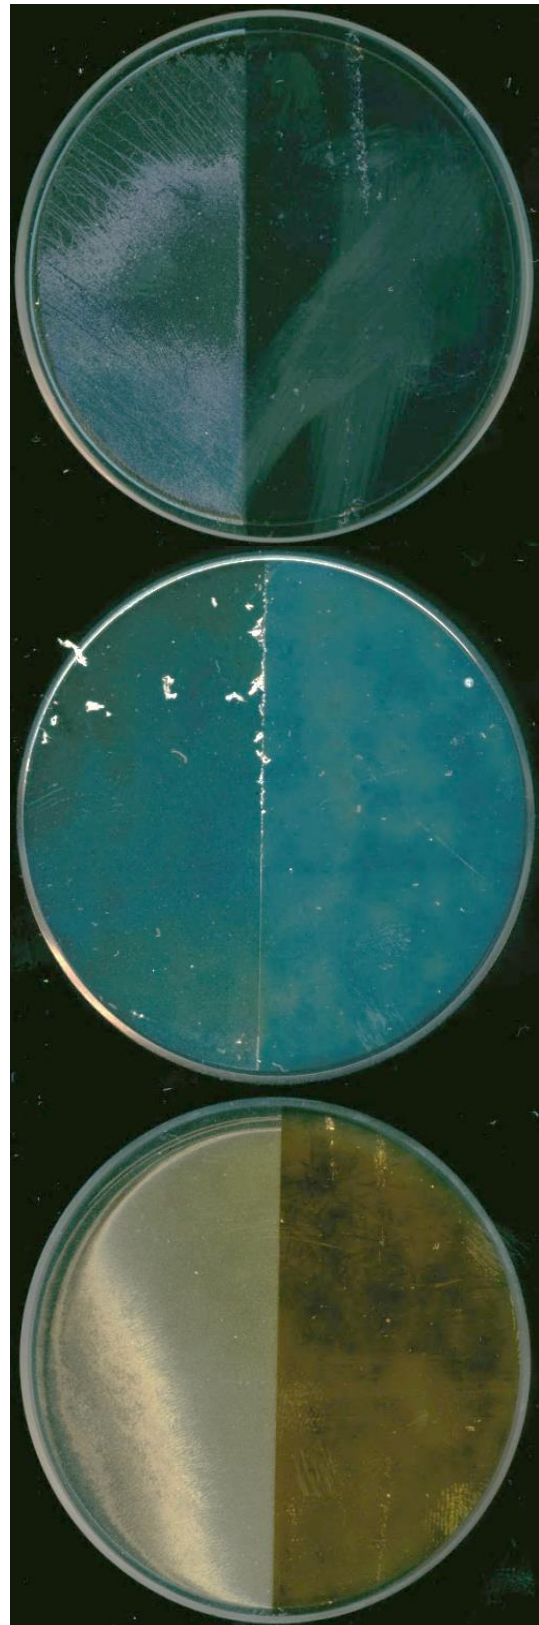
Figure 5 shows images of each of the mirrors after exposure to debris. Craters and scratches are observable deep into the substrate. The dielectric mirror was badly damaged on the unprotected side, showing signs of stress fractures in the coating. Marks on the control (right) side of the mirror were caused by handling (fingerprints and scratching) and the aluminium shield. On the silver mirror, the exposed side has suffered even damage across the surface and almost entirely removing the protective layer. On the gold mirror, the exposed surface was damaged severely - the top coating layer was completely removed and the undercoating was badly damaged too. Marks on the control surface were a result of handling.

Figure 5. The mirrors after the ‘roughing’ stage of the experiment. From top to bottom: dielectric, silver, gold. On each mirror, the left hand side is the unprotected half.

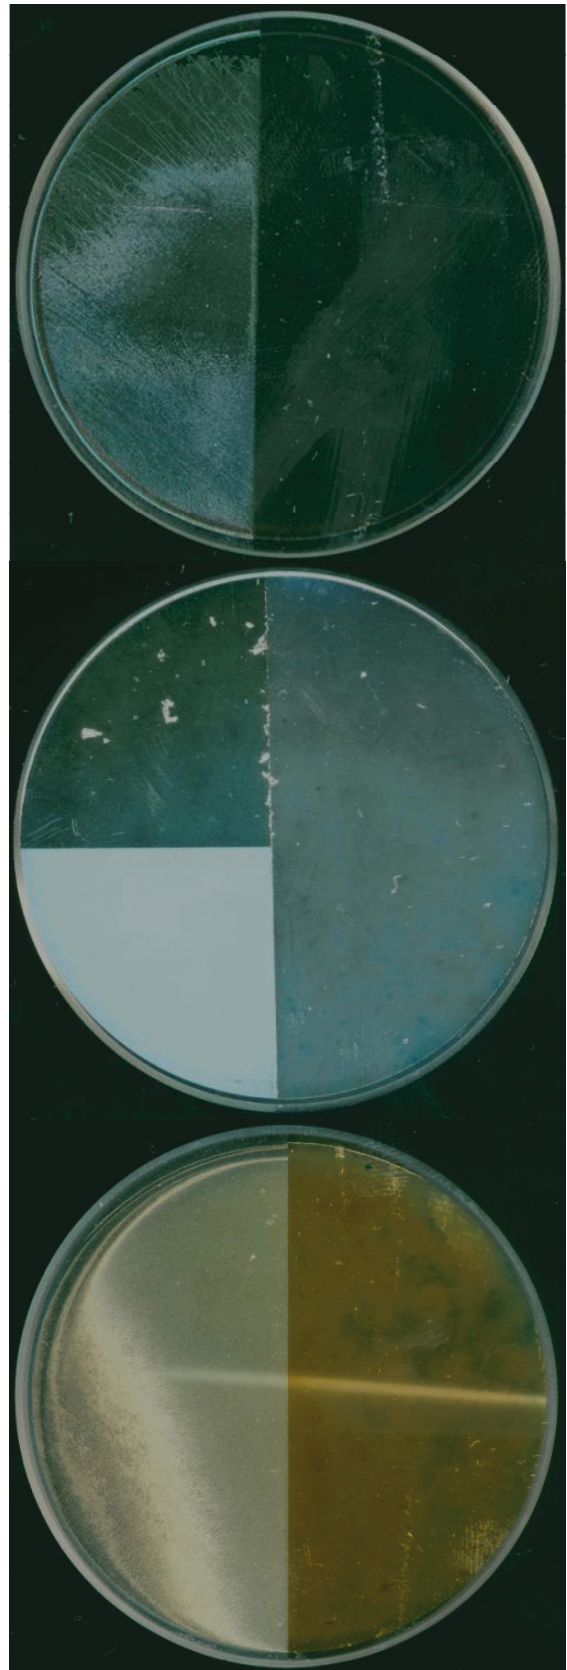
The images of the mirrors after exposure to the short pulse beam are shown in figure 6. The dielectric mirror showed no noticeable difference before and after the second stage of the testing, demonstrated by the unchanged marks on the surface of the mirror. The effects on the silver mirror are far more obvious. The quadrant which underwent the double exposure was subject to significant damage, removing almost all of the remaining coating. The undamaged, shot surface showed no changes. The gold mirror was unaffected by the second stage; the only noticeable change is a line across the two surfaces, caused by the aluminium shield.

All three mirror types tested were subject to severe damage through laser-generated target debris. The mirrors were then irradiated by a short pulse laser at fairly low energy densities – well below the specified damage thresholds of the optical coatings. The silver mirror was the only coating showing significant changes following both the debris exposure and laser. The experimental data appears to verify the working theory and has shed light on the previously unexplained reasons for the deterioration of the TAP parabola. Based on this study, the option for silver coated optics in high-debris areas needs careful consideration for lifetime and costs versus the traditional dielectric option.

Figure 6. The mirrors after the second stage of the study. From top to bottom: dielectric, silver, gold. The dielectric mirror had its top left quarter 'roughed' and exposed to the beam. The silver and gold mirrors both had the double exposure to their bottom left quarters.
