Operational damage to Petawatt gratings

Central Laser Facility, CCLRC Rutherford Appleton Laboratory, Chilton, Didcot, Oxon., OX11 0QX, UK

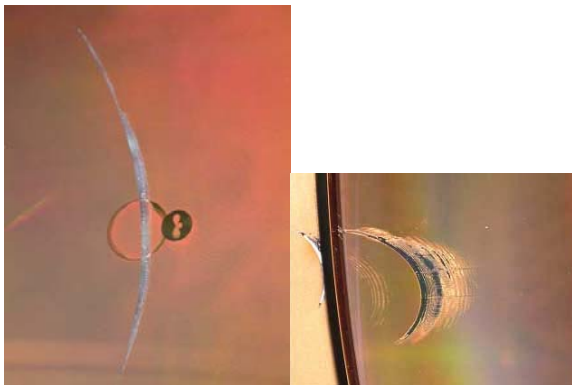
During a regular inspection of the optics within the Petawatt Compressor Chamber¹⁾ in June 2004 a significant change was observed on the first grating²⁾ of the compressor. A thin arc of approximately thirty centimetres length and, at maximum, 1 cm thick was discovered passing through the 'parsons nose', an artifact of the manufacturing process (see figure 1a). There was a further damage mark on the left of the grating which was considerably shorter than the central mark at about 5 cm long (see figure 1b).

Figure 1. a) Central damage mark on first grating. b) Left side damage mark on first grating.

On further investigation it was noted that the damage had removed the gold top layer and had made significant damage to the photoresist layer.

An investigation into the cause of the damage noted that the gold on the bezel at the right of the grating was suffering from burn damage. It was suggested that the beam had a near-field mismatch into the grating such that it hit the bezel and burnt through the gold. The beam then traveled through the substrate reflecting off the back onto the centre mark, a fraction was reflected off to do another bounce and form the second damage mark on the left of the grating.

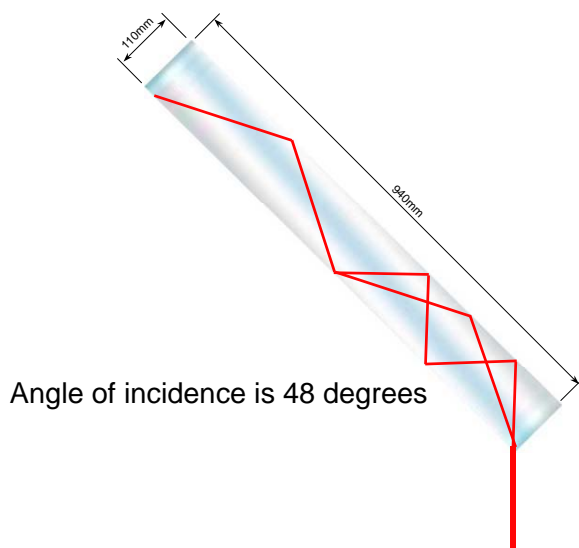
Figure 2. Diagram showing how the damage occurred to the first grating.

In the process of testing this theory by aligning a helium neon laser along the beamline edge the laser fitted exactly with the damage marks. This did not however equate to passing through the damaged bezel, but through the polished side of the grating. This also accounted for the effective focusing action due to the curved shape of the edge of the grating (figure 2). When aligned through the bezel a double bounce was observed but arrived at the front surface a quarter and a half of the way across the grating. On further inspection there is a very faint damage mark a quarter of the way across the grating. To prevent further damage an edge shield (figure 3) was designed and installed covering the edge and bezel of the grating.

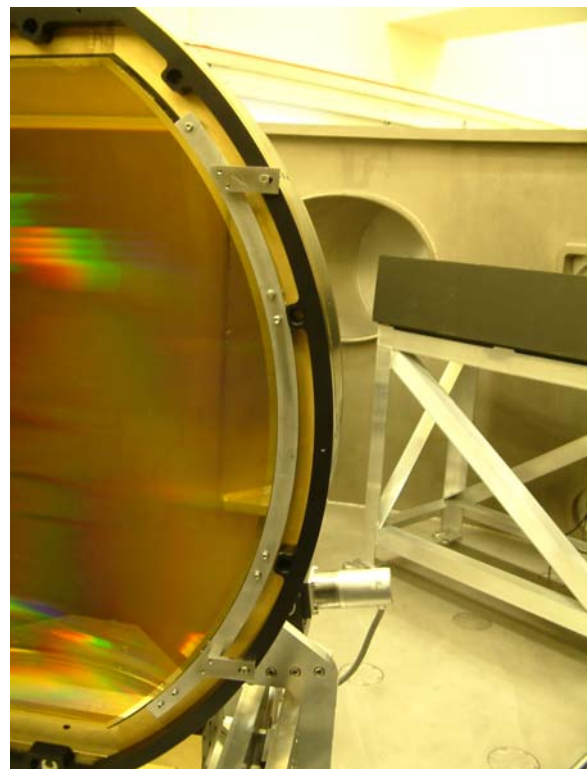
Figure 3. Grating showing edge shield.
